National Register of Historic Places Registration Form

Historic name: Gird Point Lookout

L-4 Fire Lookouts in the USFS Northern Region (Region 1), 1932-1967

Other: "Readicut" L-4 Lookout House

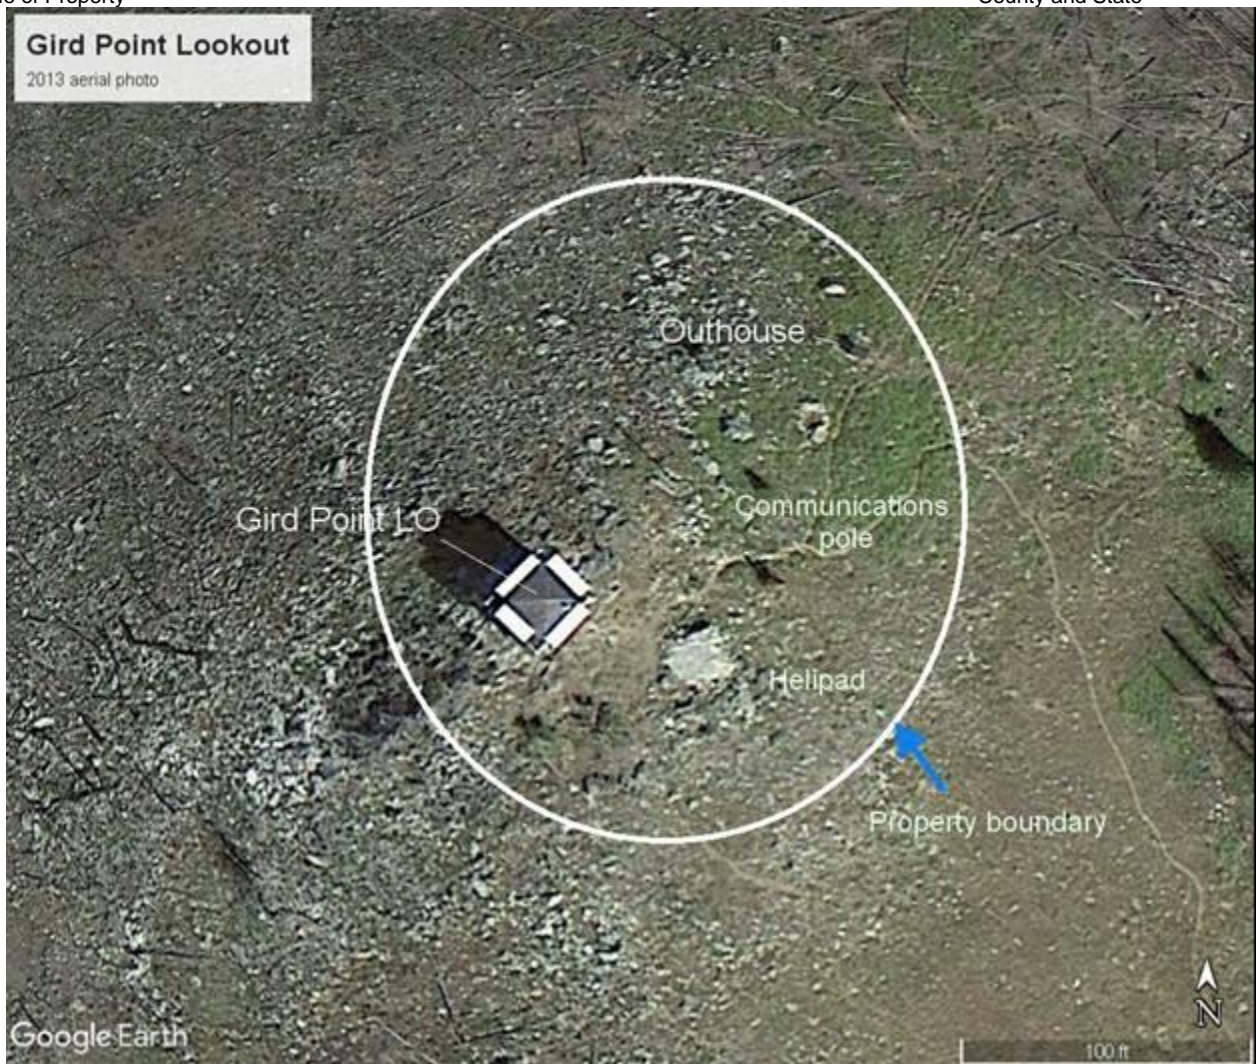
Gird Point Lookout site plan, 2013 aerial photo.

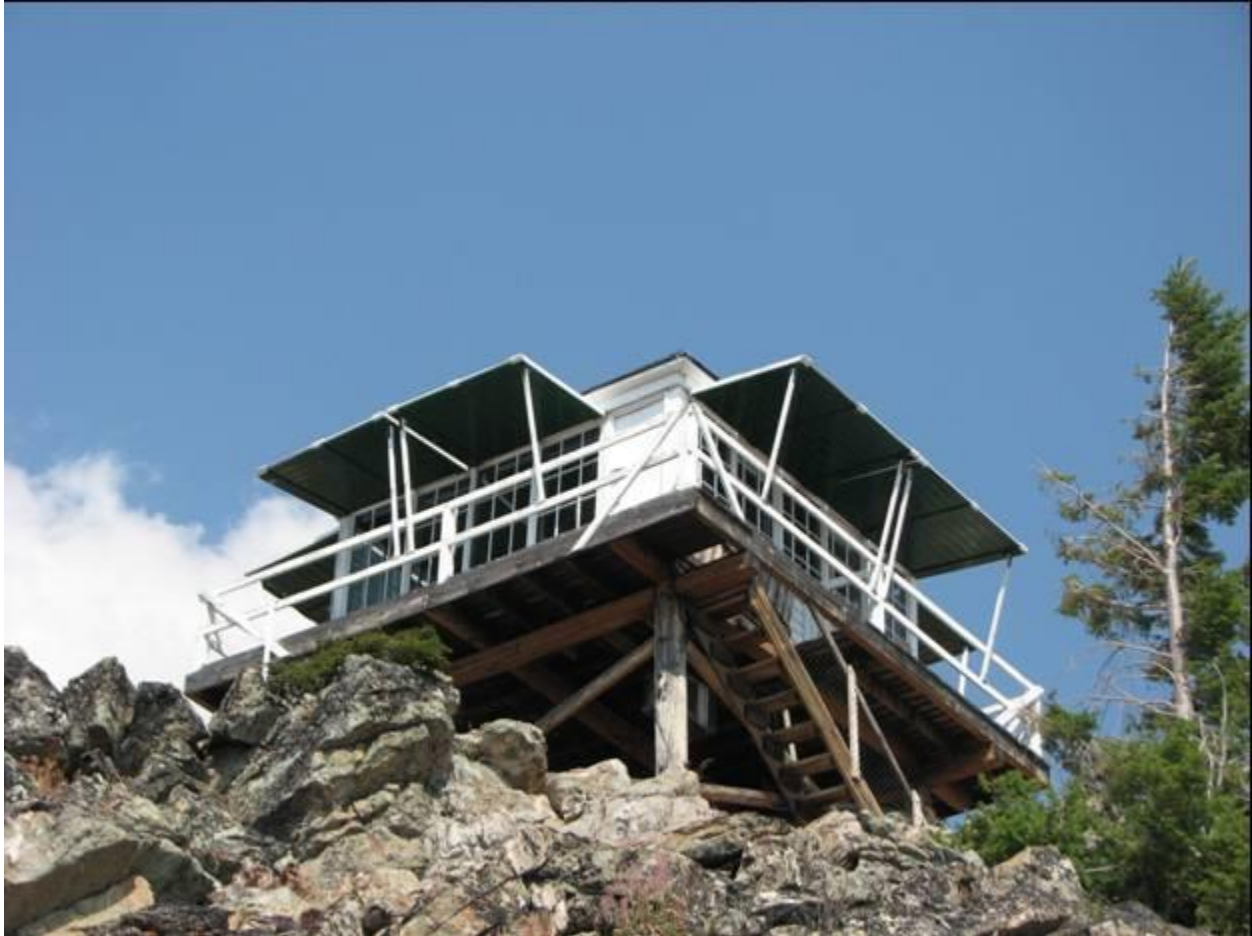
Gird Point Lookout (contributing building) Gird Point Lookout is a 14-foot by 14-foot wood frame lookout cab with a pyramidal roof built atop a 10-foot high, log tower. The tower and cab are aligned so that they sit at a 45 degree angle to the cardinal directions. Simple drop wood siding covers the lower portion of the exterior walls, and the roof is covered with sawn cedar shingles with metal ridge caps. A metal stove pipe extends above the southeast slope of the roof at its north end. The entry into the lookout house is located at the east end of the southwest-facing wall. A modern wood board-and-batten door has replaced the original multi-light door. Four nine-light windows are located in the wall west of the entry. The remaining three walls each contain five, nine-light, wood windows, two of which slide sideways allowing ventilation. Several of the window panes are missing—the holes covered with cardboard. Each

MT_RavalliCounty_GirdPointLookout_0001. Looking north to the southwest (front) and southeast sides of Gird Point Lookout.

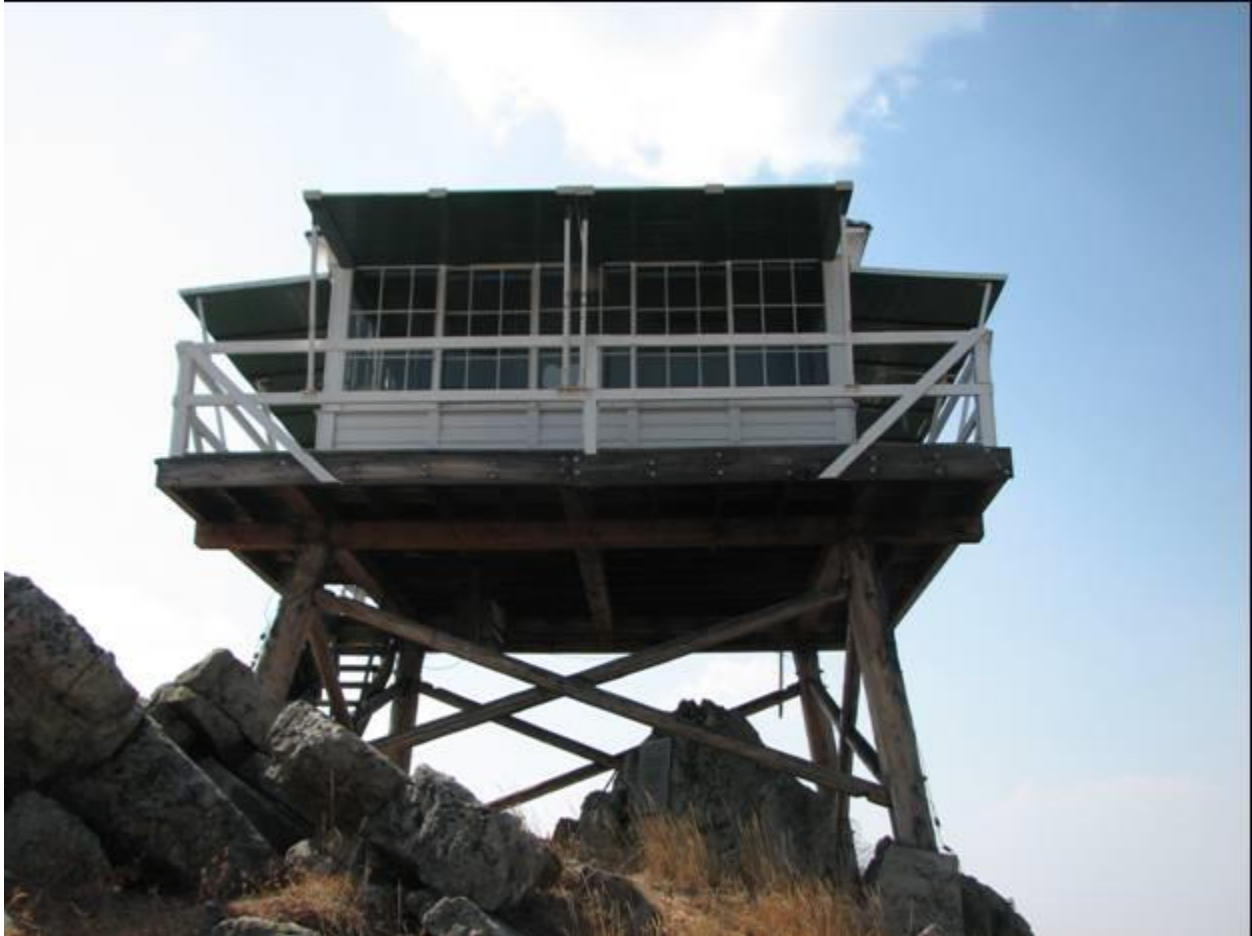
MT_RavalliCounty_GirdPointLookout_0002. Looking southwest to the northeast wall of the lookout.

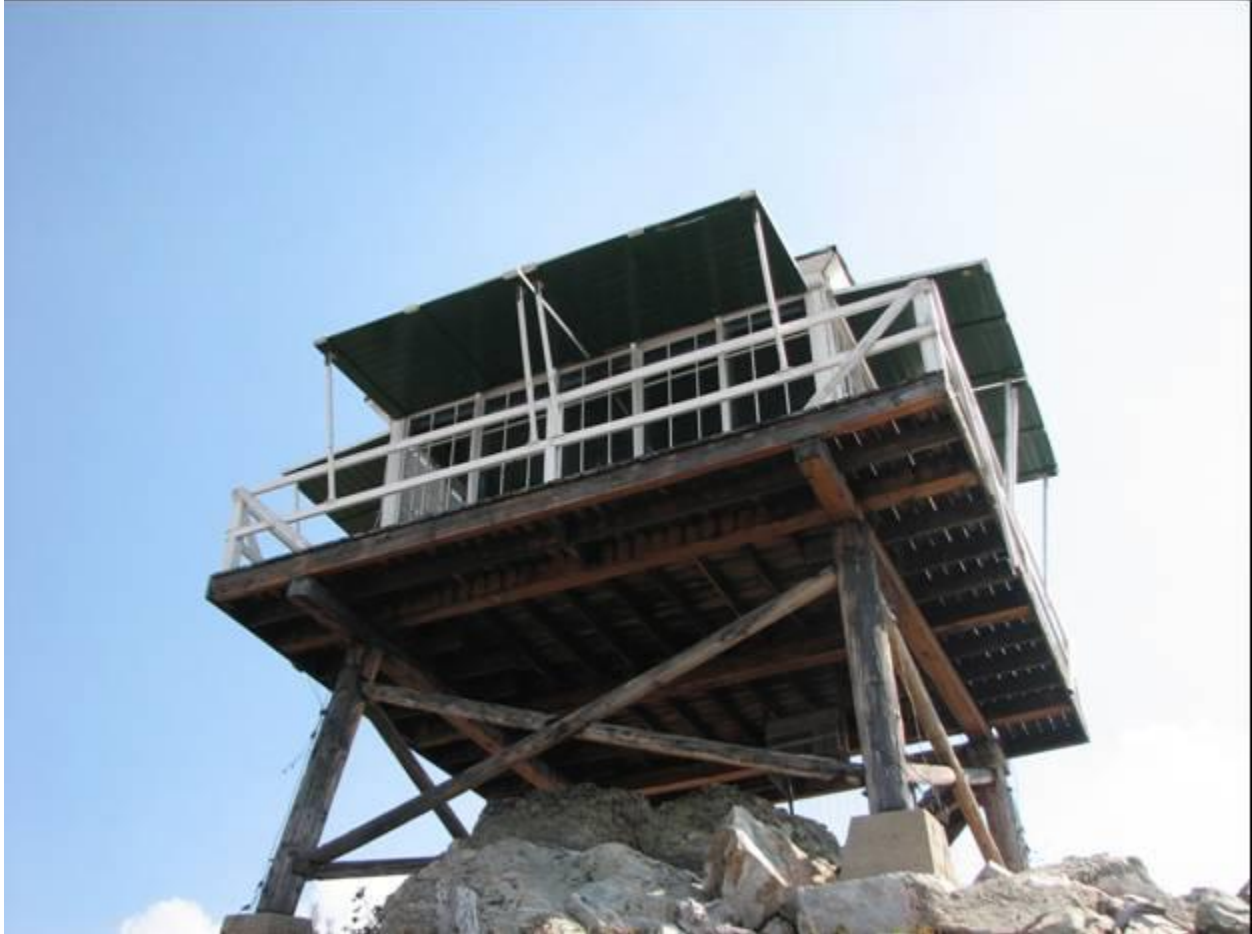
MT_RavalliCounty_GirdPointLookout_0003. Looking southeast at the northwest wall of the lookout.

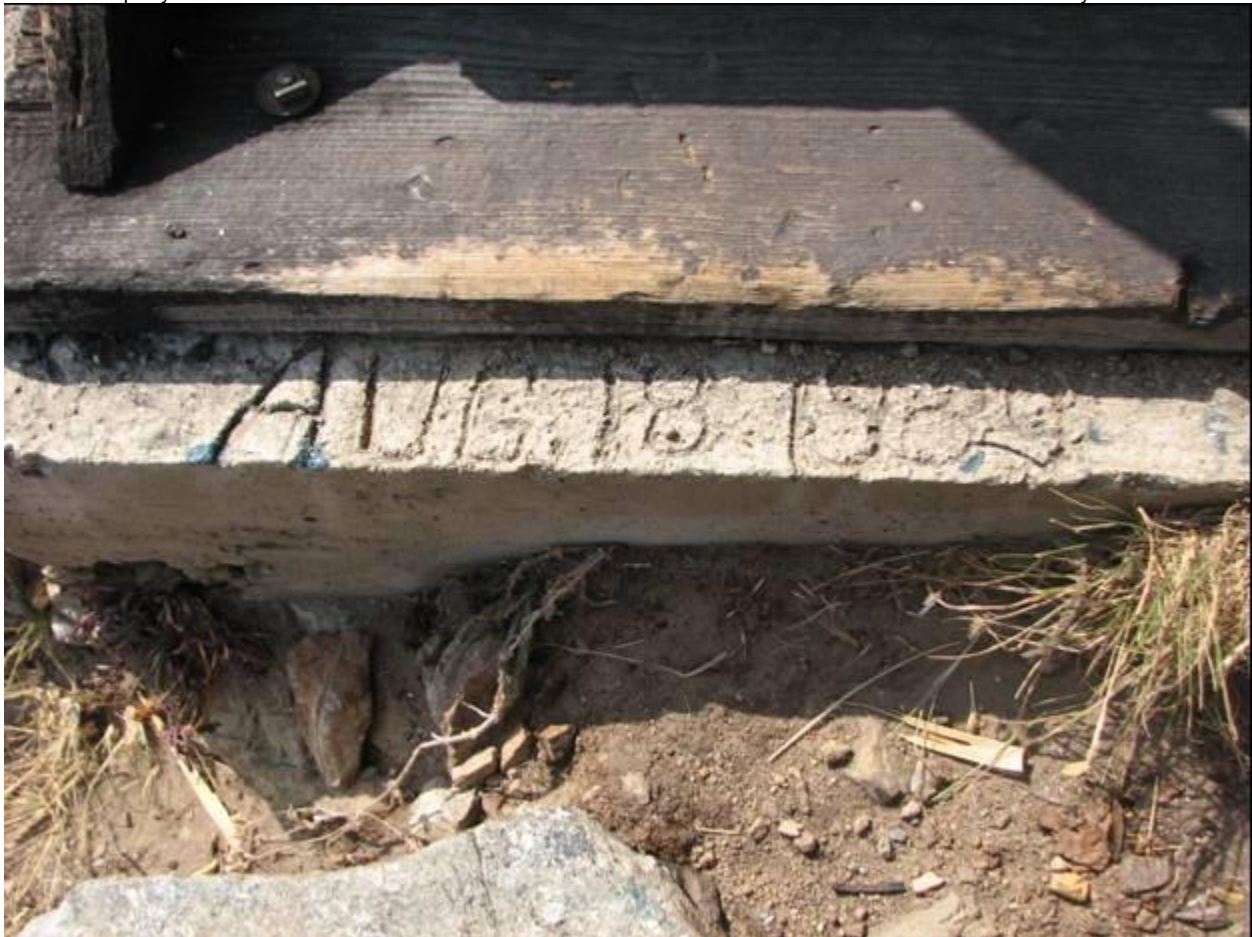
The four log legs of the cross-braced log tower are supported by cast-in-place battered concrete footings. A single-flight stairway is located on the southeast side of the lookout tower. The base of the stairway rests on a concrete footing etched with: "Aug. 18 1939." The stair stringers and treads are made with dimensional lumber. A safety railing on the outside edge of the stairway has been fashioned by attaching hog wire to a dimensional lumber hand rail which in turn is attached to two vertical wood posts. A small wooden storage box is suspended from the base of the cab adjacent to the inside edge of the stair. Originally, the box could be accessed by someone standing on the stair, however, access is now blocked by wire mesh attached to the inside edge of the stair. At the top of the stairway, a trapdoor leads to the catwalk that surrounds the cab. A spring-loaded safety gate is located the north edge of the trap-door opening.

MT_RavalliCounty_GirdPointLookout_0004. Detail of the concrete footing for the stair etched with "Aug. 18 1939."

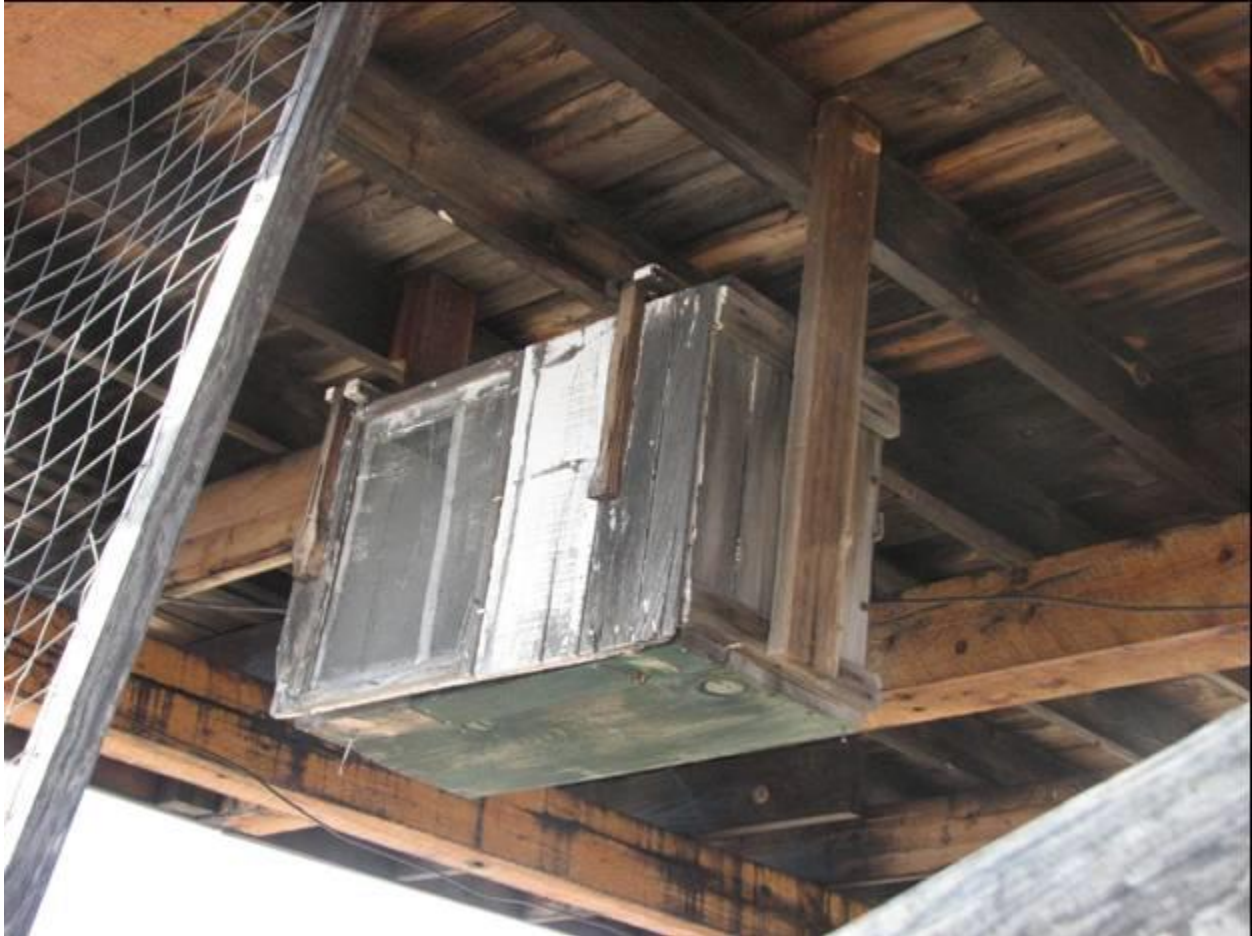
MT_RavalliCounty_GirdPointLookout_0005. Wood storage box suspended from the base of the lookout.

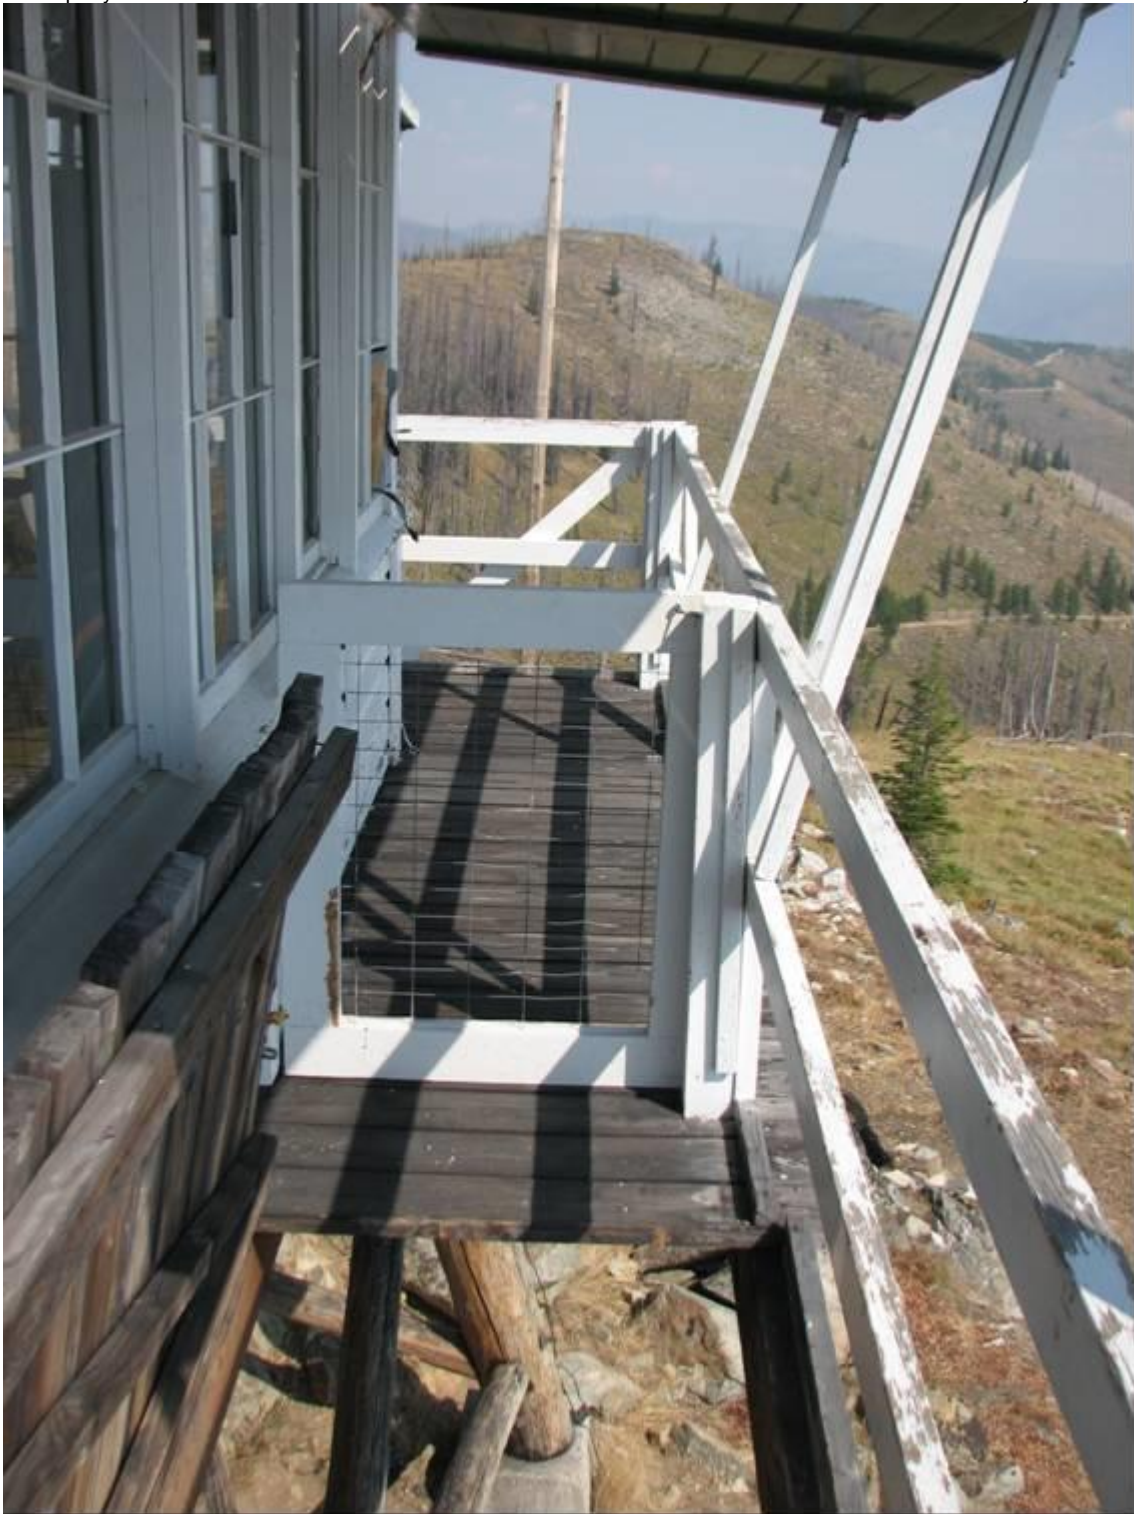
MT_RavalliCounty_GirdPointLookout_0006. Looking northeast to the spring-loaded safety gate at the edge of the trap door in the northeast side of the catwalk.

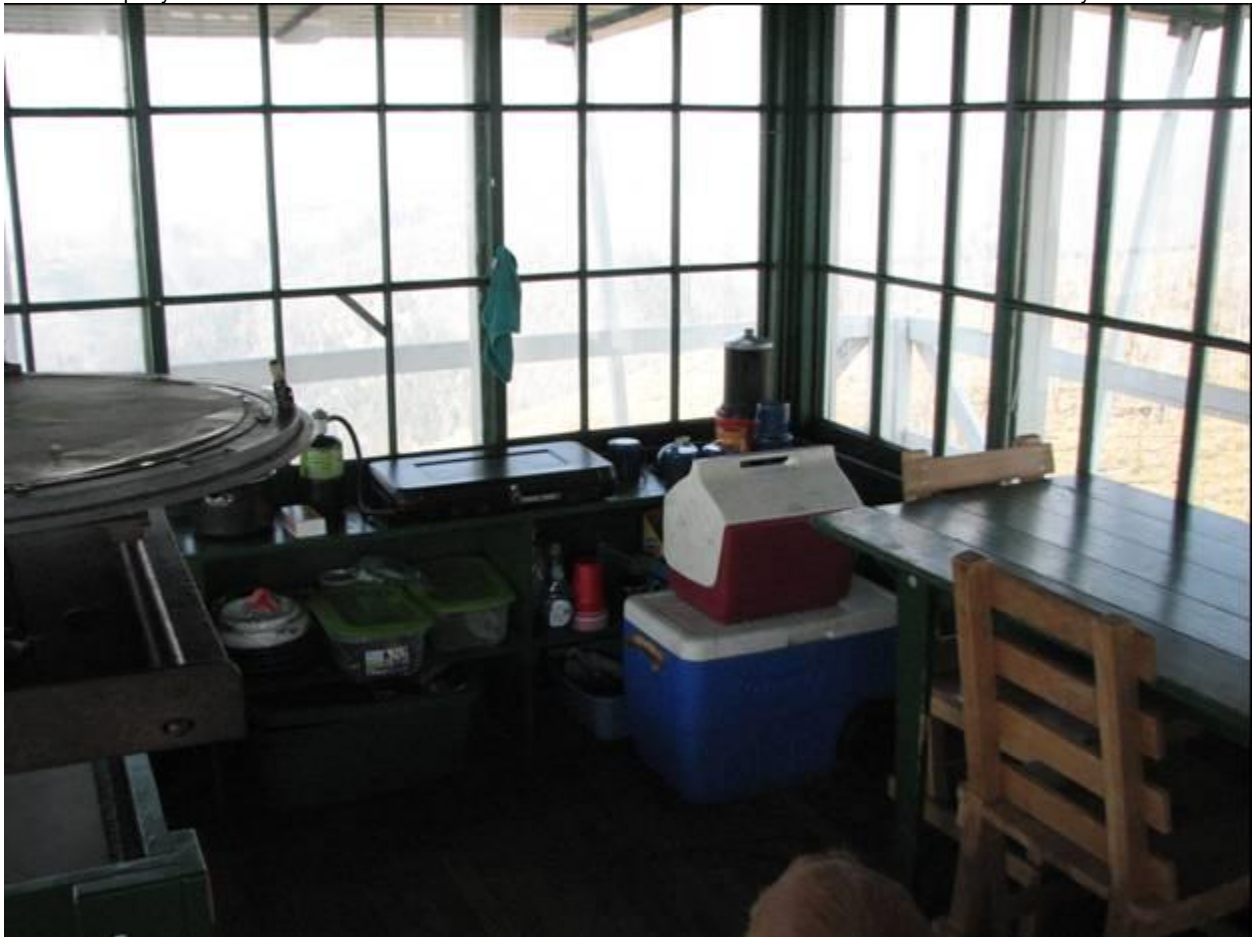
In the one-room interior, the original maple floor is intact and in fair condition. The interior is fitted with a plywood platform bed frame, a metal stand with an Osborne fire-finder, a small wood heating stove, a small table, and a storage bench.

MT_RavalliCounty_GirdPointLookout_0007. Interior, showing table and shelves.

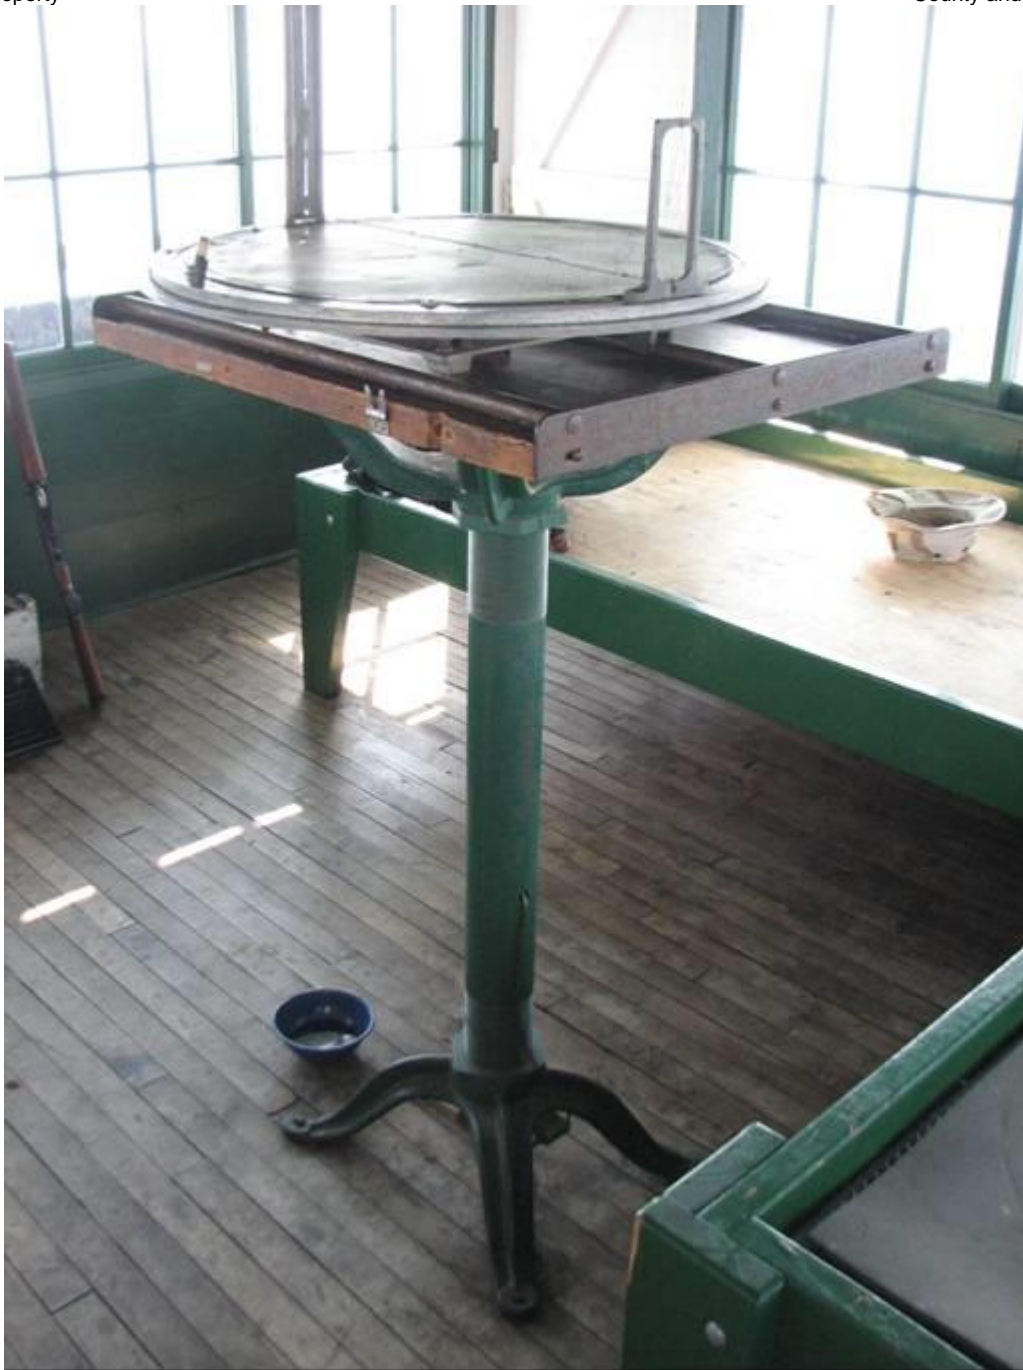
MT_RavalliCounty_GirdPointLookout_0008. Interior showing platform bed frames and fire-finder stand.

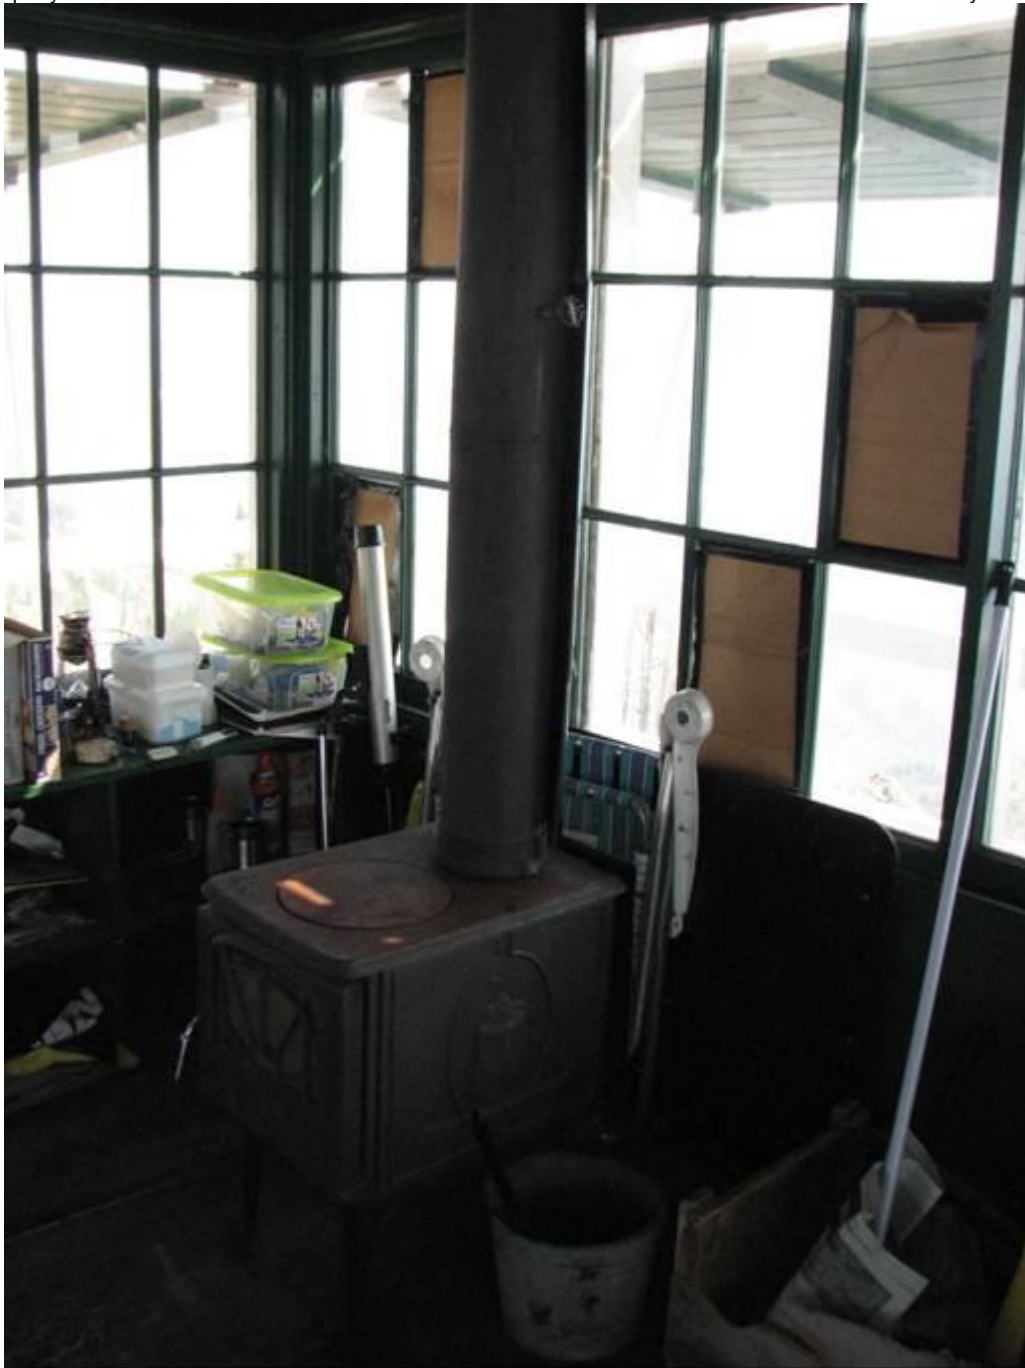
MT_RavalliCounty_GirdPointLookout_0009. Interior: wood stove.

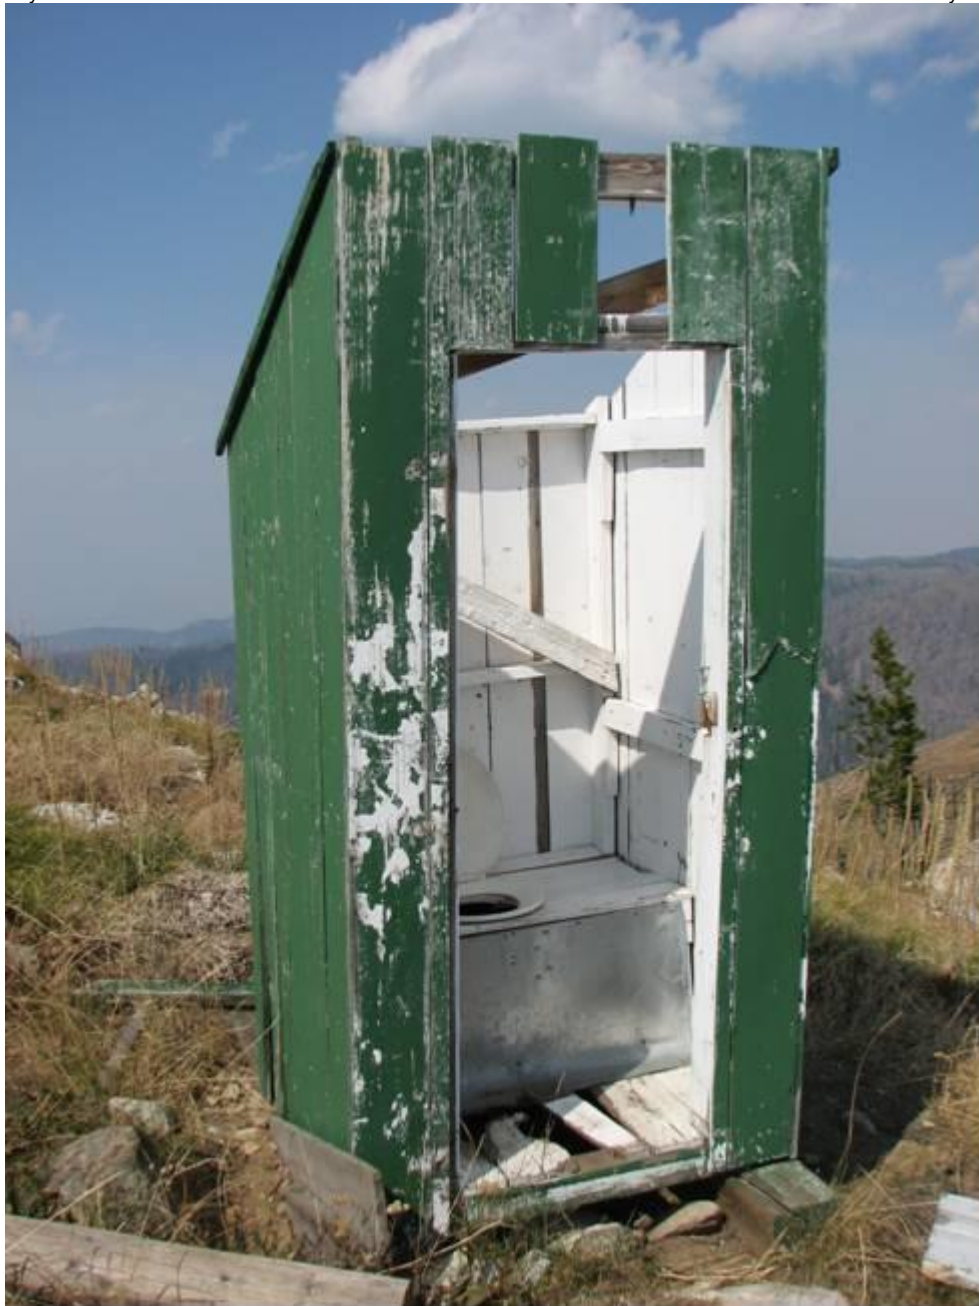
Outhouse (contributing building) The outhouse is located roughly 120 feet northeast of the lookout. It is a one-story frame building with a steep shed-style roof. The exterior walls are enclosed with vertical boards. At the time of the survey the outhouse was in poor condition. The roof is missing and the original, Z-braced, vertical board door lay on the ground. The Forest Service intends to replace the outhouse in the near future.

MT_RavalliCounty_GirdPointLookout_0010. Looking west to the south and east sides of the outhouse.

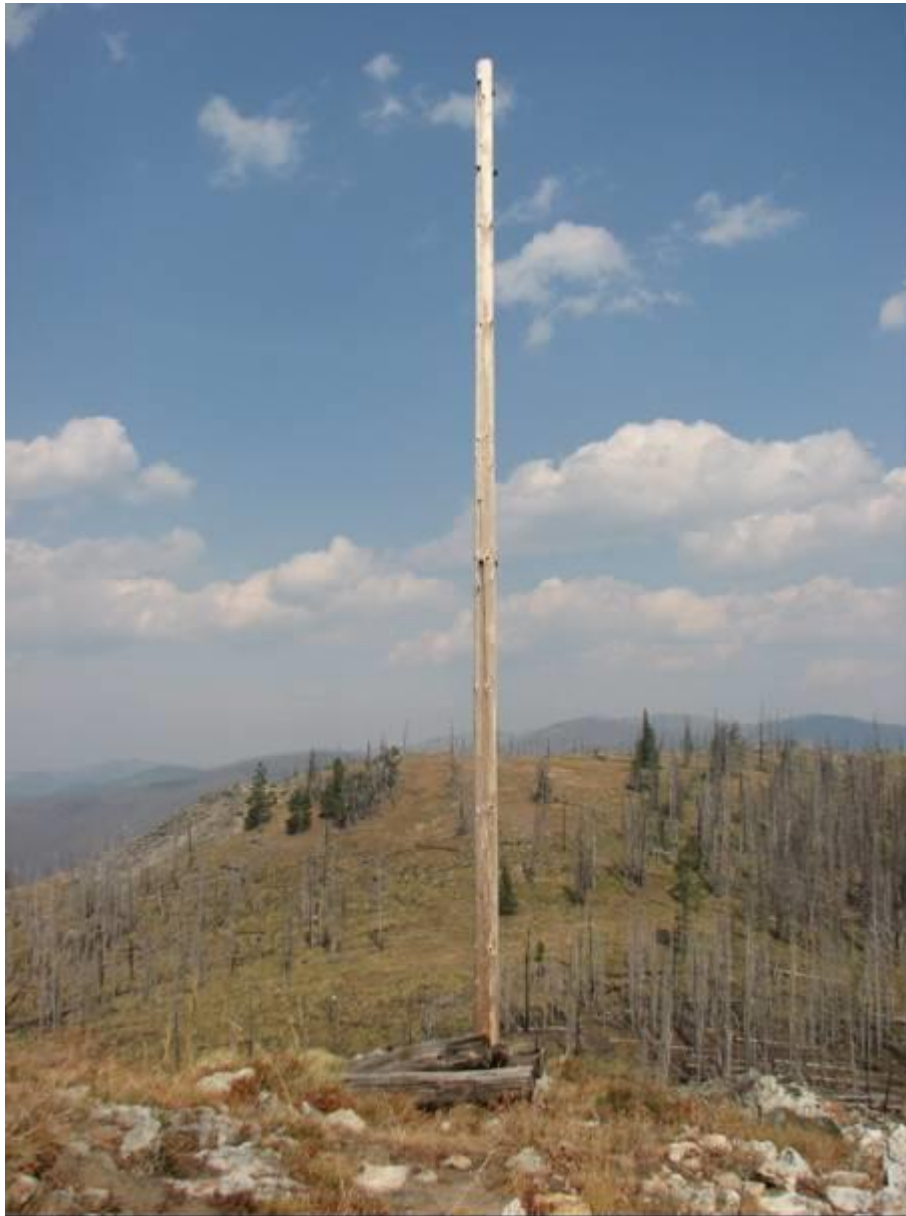
Communications pole (noncontributing structure) A recently-erected peeled log pole, presumably to support communications antennae, is located about 40 feet northeast of the lookout.

MT_RavalliCounty_GirdPointLookout_0011. Looking northeast to the communications pole.

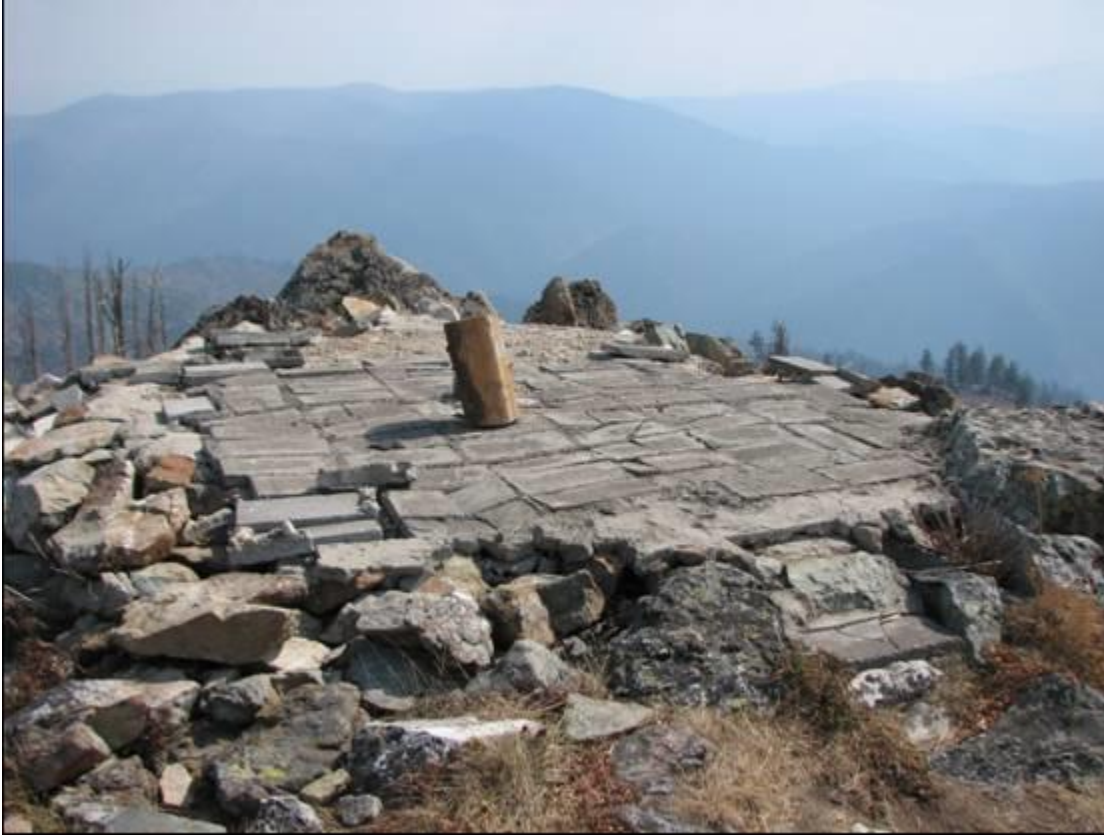
Helipad (noncontributing structure) A small helipad is located about 25 feet east of the lookout. It consists of a 10-foot by 12-foot leveled area within a natural talus outcrop that has been paved with concrete blocks.

MT_RavalliCounty_GirdPointLookout_0012. Looking southeast over the helipad.
